# ABANDONED MINE ISSUES IN PA CONGRESSIONAL DISTRICT 15

Map created 03/2025  
by Michael Hewitt,  
EPCAMR Program Manager  
[www.epcamr.org](http://www.epcamr.org)

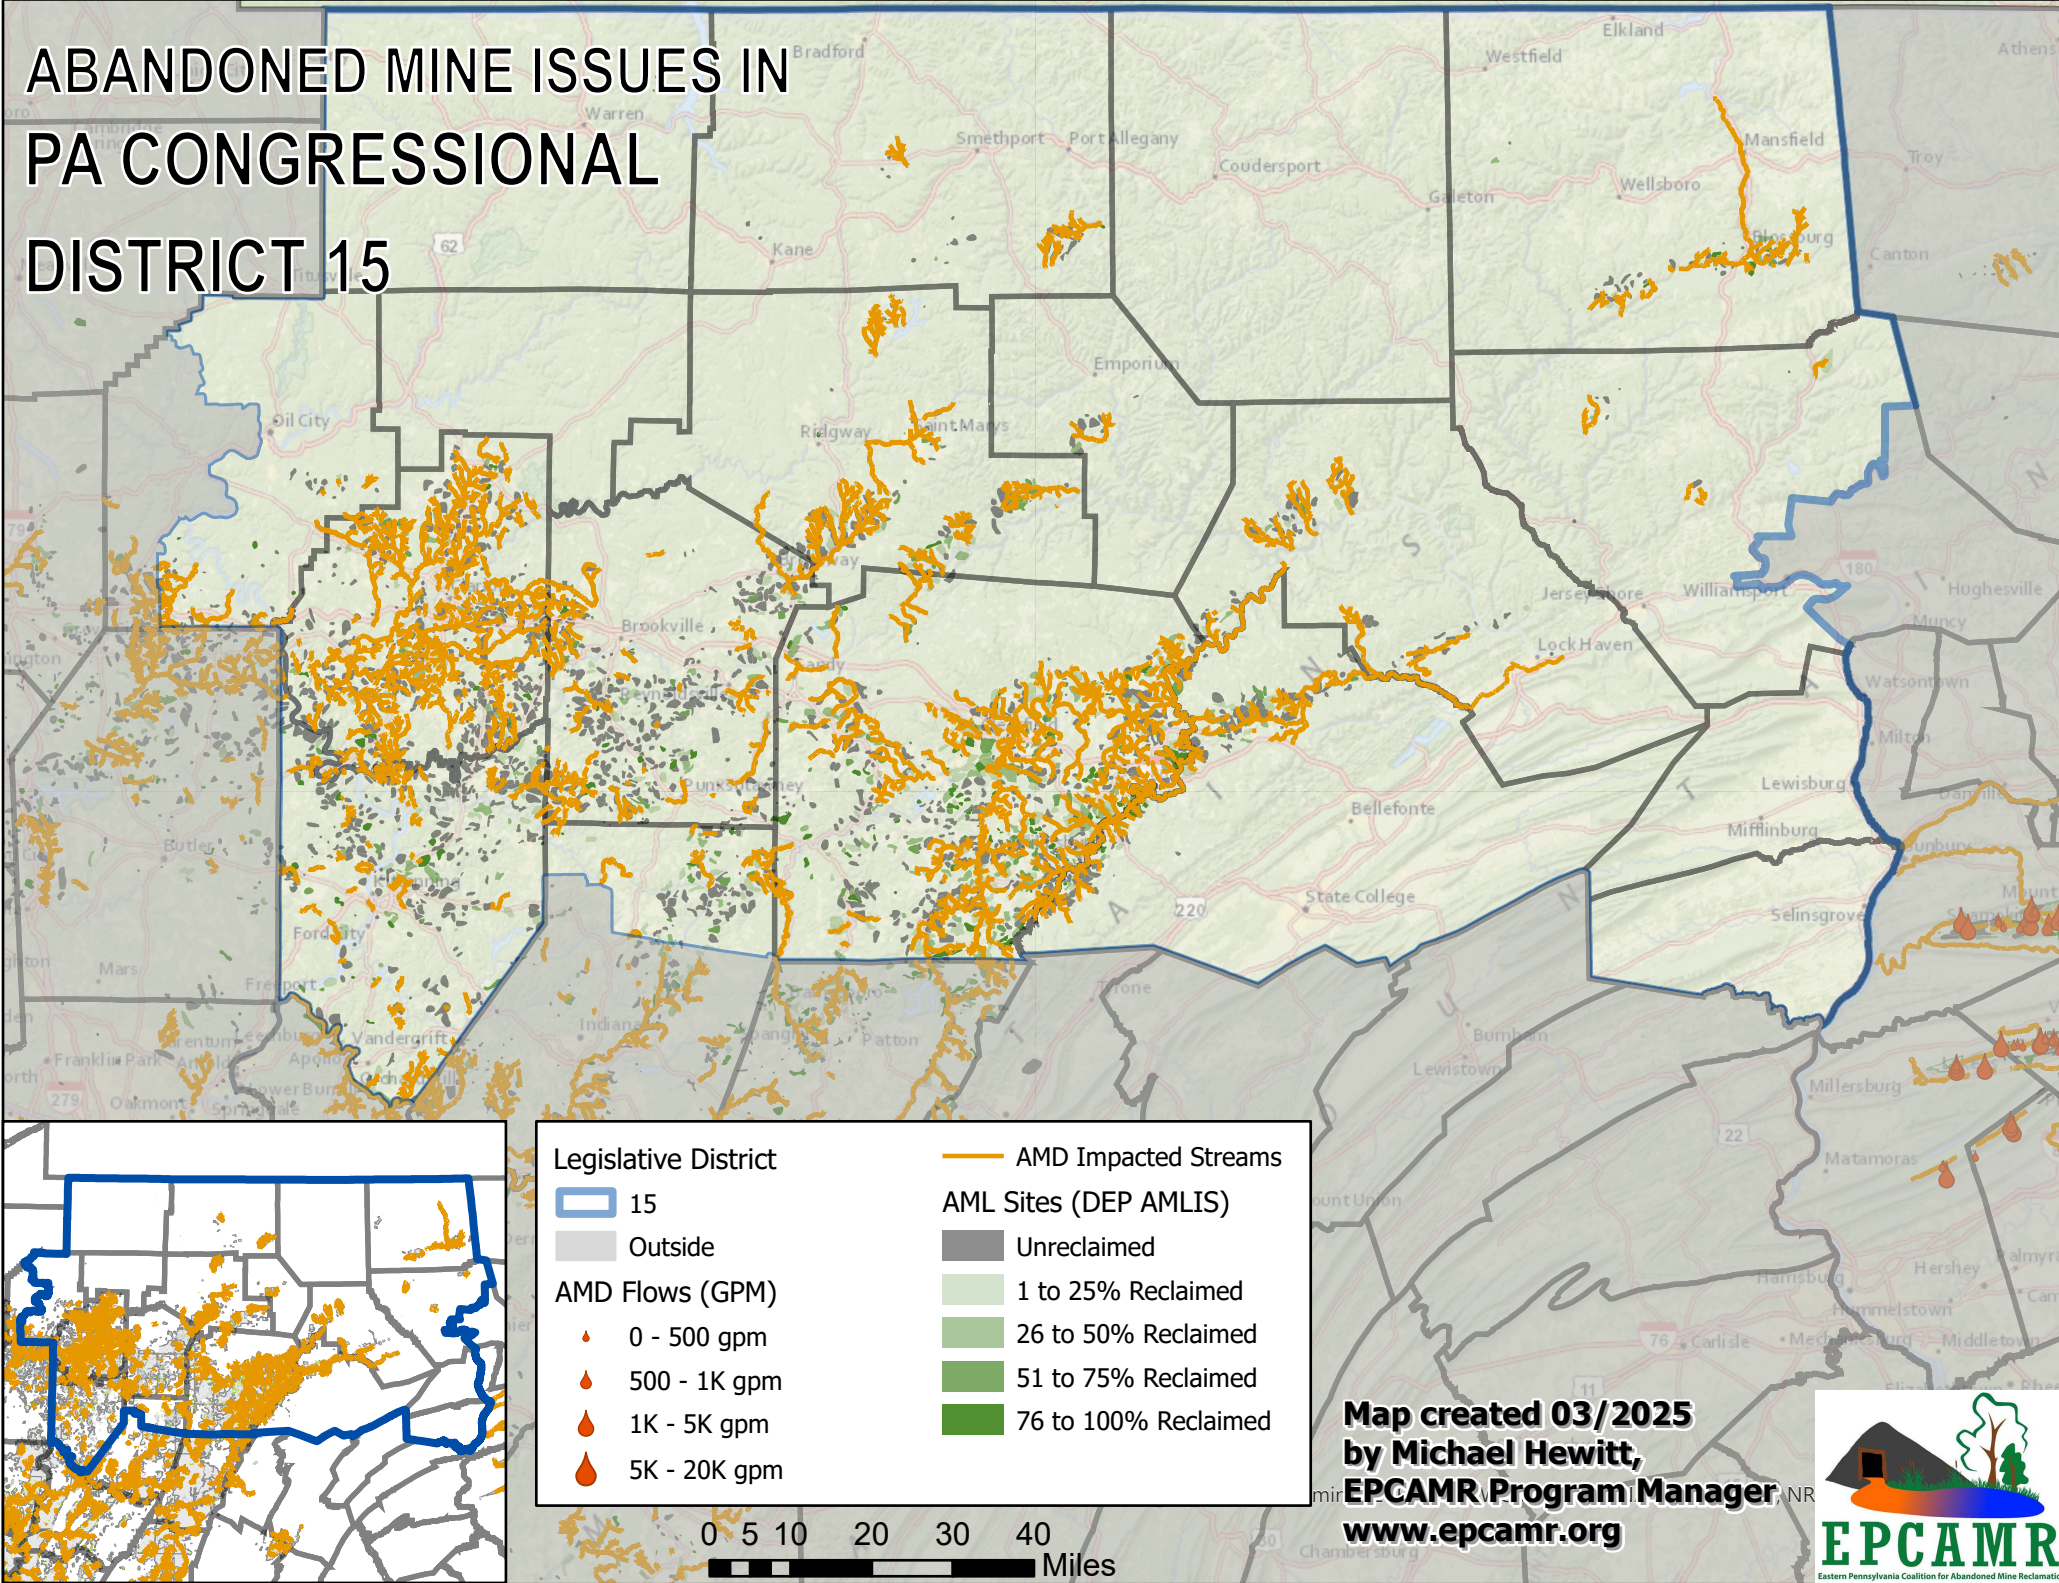
<b>Legislative District</b>	AMD Impacted Streams
15	<b>AML Sites (DEP AMLIS)</b>
Outside	Unreclaimed
<b>AMD Flows (GPM)</b>	1 to 25% Reclaimed
0 - 500 gpm	26 to 50% Reclaimed
500 - 1K gpm	51 to 75% Reclaimed
1K - 5K gpm	76 to 100% Reclaimed
5K - 20K gpm
